# AGC-1 Post-Irradiation Examination Status

W. Swank

September 2011

INL/EXT-11-23165

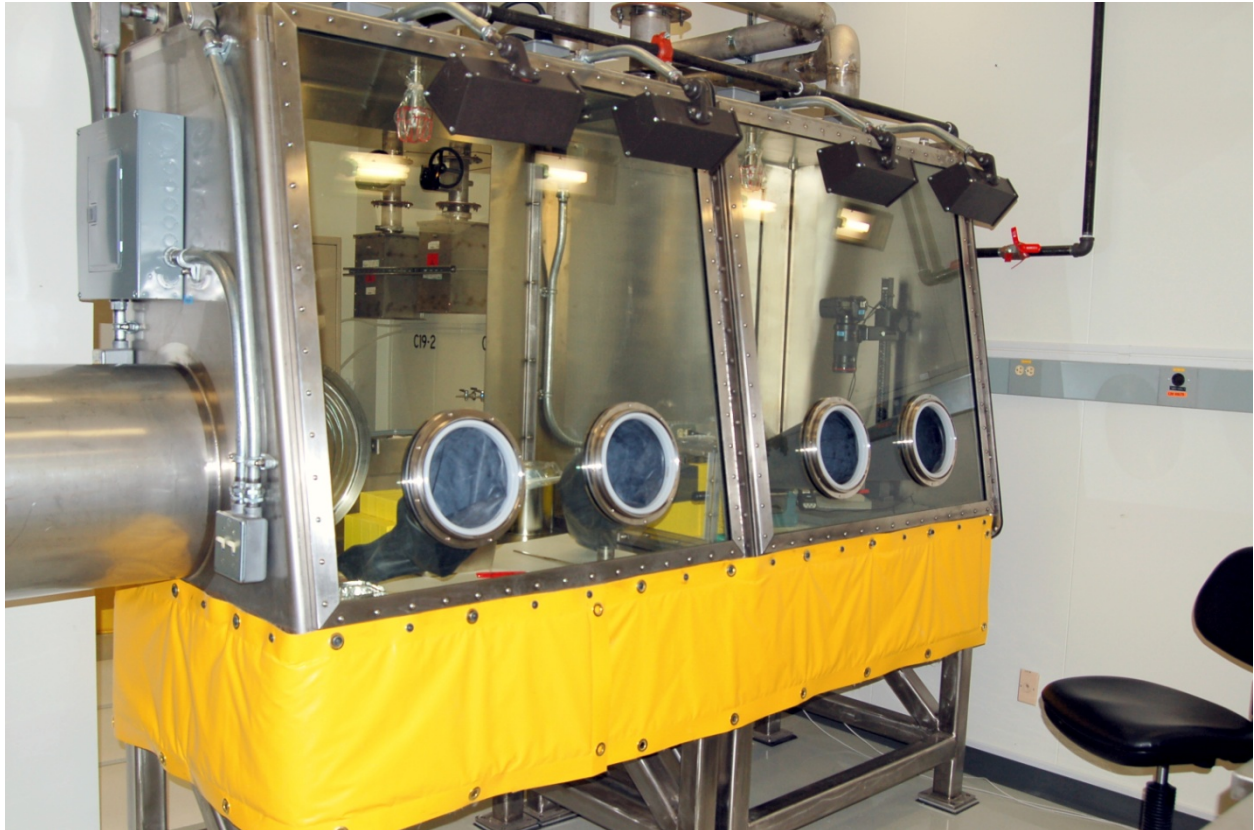
**Figure 1. CCL glovebox used to visually inspect graphite samples, perform initial dimensional measurement, and repackage samples for storage in the irradiated graphite vault located in Lab C19.**

The CCL is located in Labs C-19 and C-20 of the IRC. It was specifically designed to support graphite and ceramic composite R&D activities<sup>2</sup>. The CCL is designed to characterize and test low activated irradiated materials such as high-purity graphite, carbon-carbon composites, and silicon-carbide (SiC) composite materials. The laboratory is fully capable of characterizing material properties for both irradiated and nonirradiated materials. All test specimens from each of the six capsules will be processed through the CCL to visually inspect each sample, perform initial dimensional changes, and repackage the samples for shielded storage in the NGNP irradiated graphite vault located in Lab C-19 as shown in Figures 1 and 2.

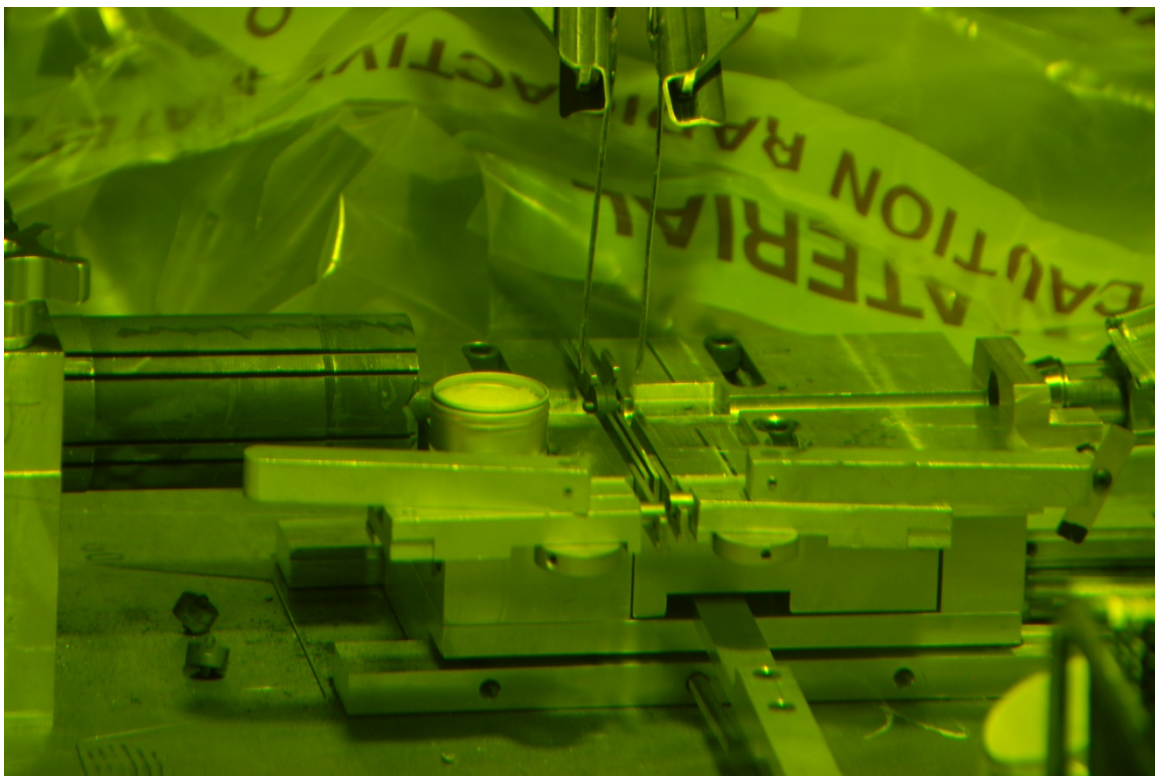
Figure 17. Initial design in use - Flux wire spacer trapped in separation hooks on the sorting table.
